Manhole Inspection Summary

Manhole # S27I__041MH

Insp Date: **5/27/08 1:06 PM**

Location Address: **855 Hayes St**

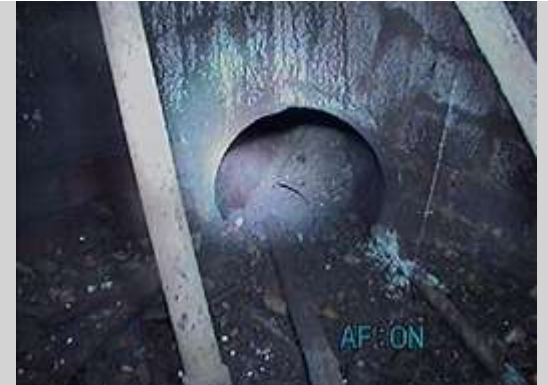
12 O'Clock Outflow

8 in. Circular Gravity Sewer
Pipe Out @ 12 O'Clock

Infiltration: **None** Pipe Seal Cond: **Sound**
